Demonstration Version *Home Inspection Report*

555 Anywhere USA

PROPERTY INSPECTION REPORT

Prepared For: Bob Everybody
Concerning: 555 Anywhere Street Typical, US
Inspection Date: 1/28/2016
By: Inspector Name: Demonstration Inspector License Number: 6199 Date:
Signature:
Phone: E-Mail:

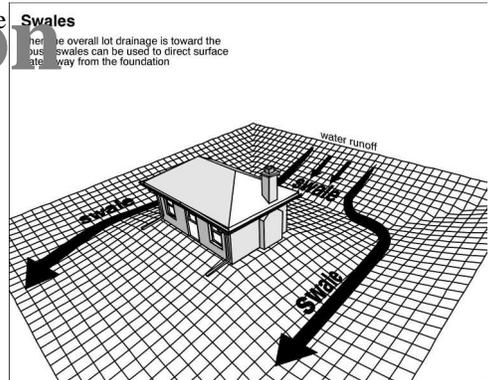
B. Grading and Drainage - Comments: Flat. The general topography of the area is such that it will be difficult to control storm water runoff. During heavy rains the accumulation of storm water on the lot may be unavoidable.

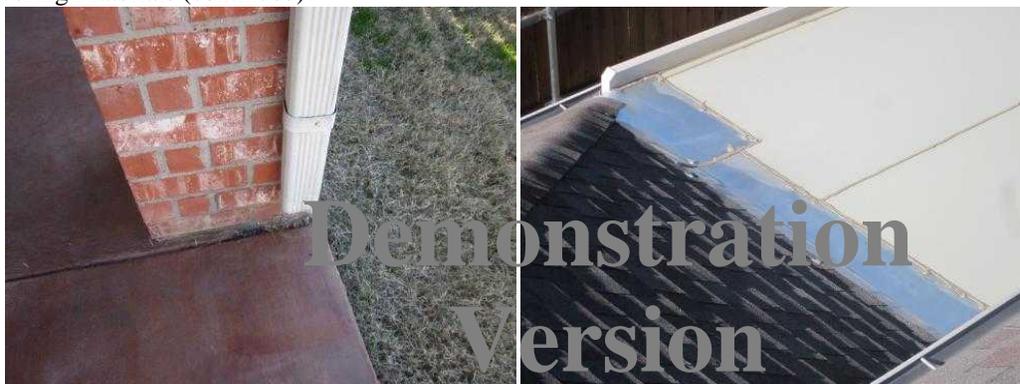
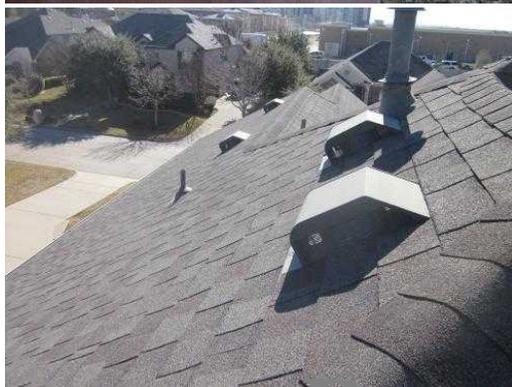
Comments: Asphalt shingle Recommend monitoring the flashing from the main roof line to the patio covering. Although functioning at the time of this inspection these particular areas can be vulnerable over time and may need repairs in the future.

Recommend repairing the downspouts around the perimeter of the home to allow for proper discharge.

Final picture is just to illustrate that the profile vents were installed and appeared to be functioning as intended at the time of this inspection.

Due to the nature of the architectural design it is recommend the area above the front entrance be monitored for any future leaks due to the type of water discharge on this design of home. Although no moisture is noted at the time of this inspection it is recommended that the area be monitored and repaired if and when repairs are needed.

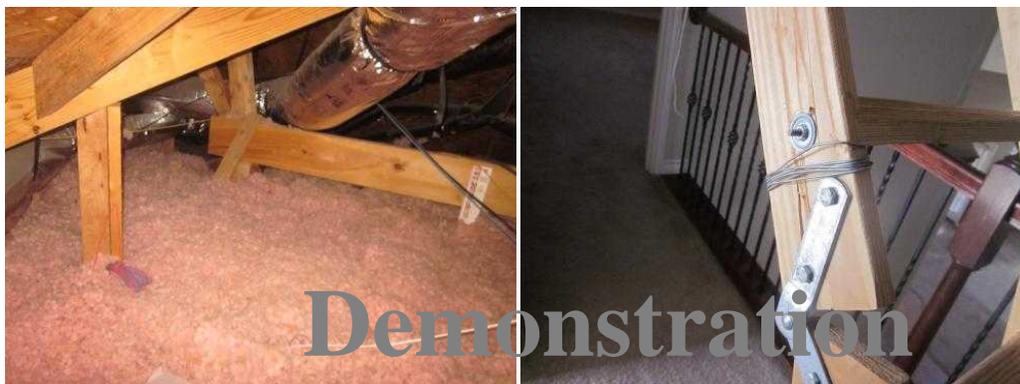
Comments: 2x6 Truss Insulation levels are appropriate at the time of the inspection and no additional insulation is recommended at this time.

Recommend repairing the attic ladder to prevent an injury or damage.

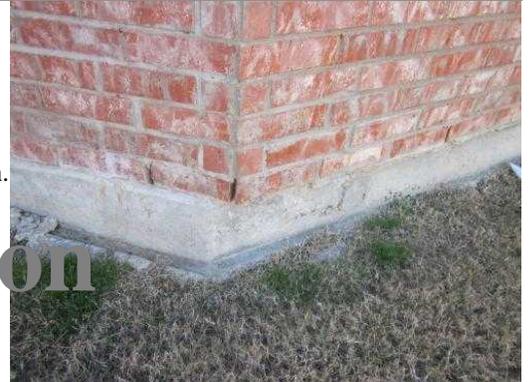
E. Walls (Interior and Exterior) - Comments: Drywall/Brick, Nail pops are noted in various locations and should be repaired in the near future.

The interior of the home is need of cosmetic repairs, but overall structural condition appears to be functioning as intended at the time of this inspection.

It appears that the exterior brick line is over hanging from the original concrete layout. Does not appear to be affecting the performance of the foundation but recommend monitoring and repair as needed.

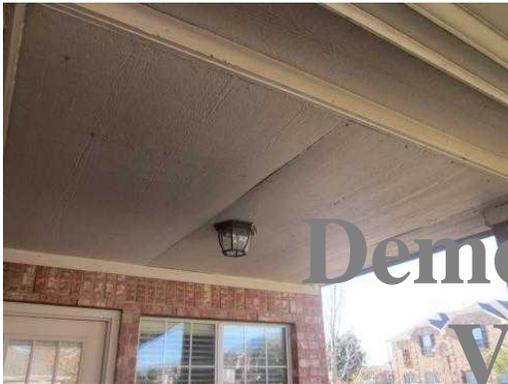
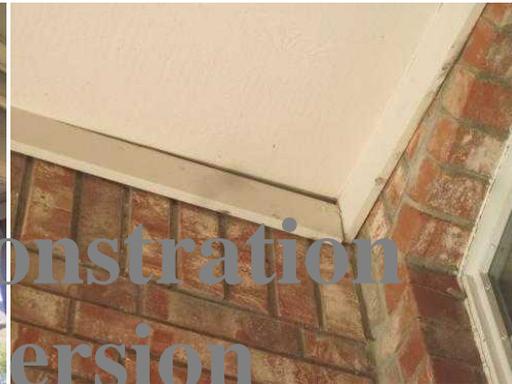
F. Ceilings and Floors - Comments: Drywall and Carpet, The exterior patio covering is showing signs of sagging which may be caused by water intrusion into the area or from improper installation. Further evaluation may be warranted to determine the actual cause.

Areas of separation area noted around various locations of the exterior trim and should be repaired.

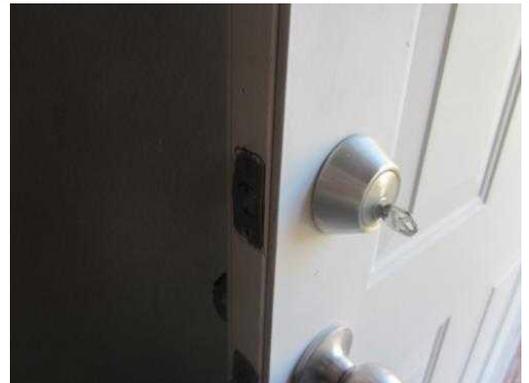
G. Doors (Interior and Exterior) - Comments: Insulated steel doors, The dead bolt lock does not line up properly for the smaller garage door. Further adjustments are recommend to allow for ease of use.

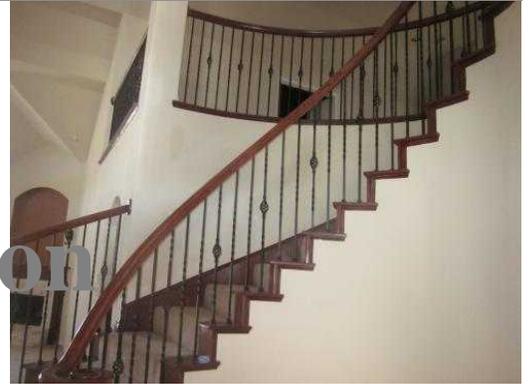
I. Stairways (Interior and Exterior) - Comments: Wood stairs with wood handrails, The stairway banister and rail are loose and should be secured.

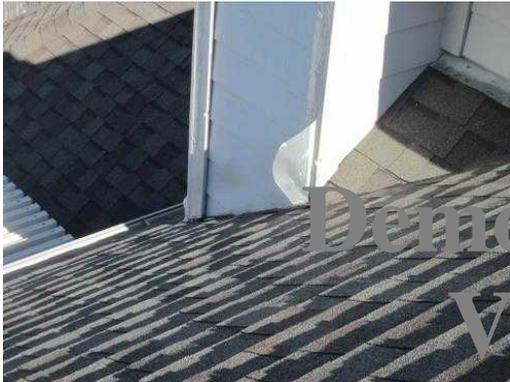
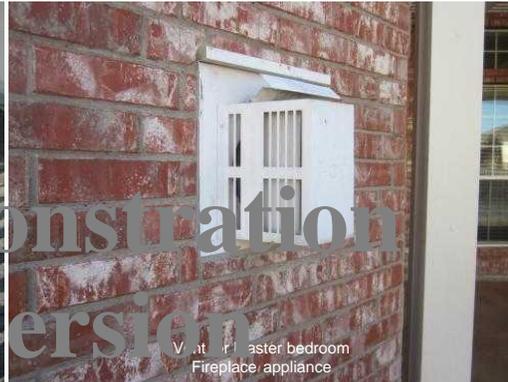
J. Fireplaces and Chimneys - Comments: Prefab, Wood trim for the living room chimney is showing signs of rot and should be repaired in the near future.

Recommend cleaning out the living room fireplace.

Fresh air vent for the living room fireplace is damaged and should be replaced.

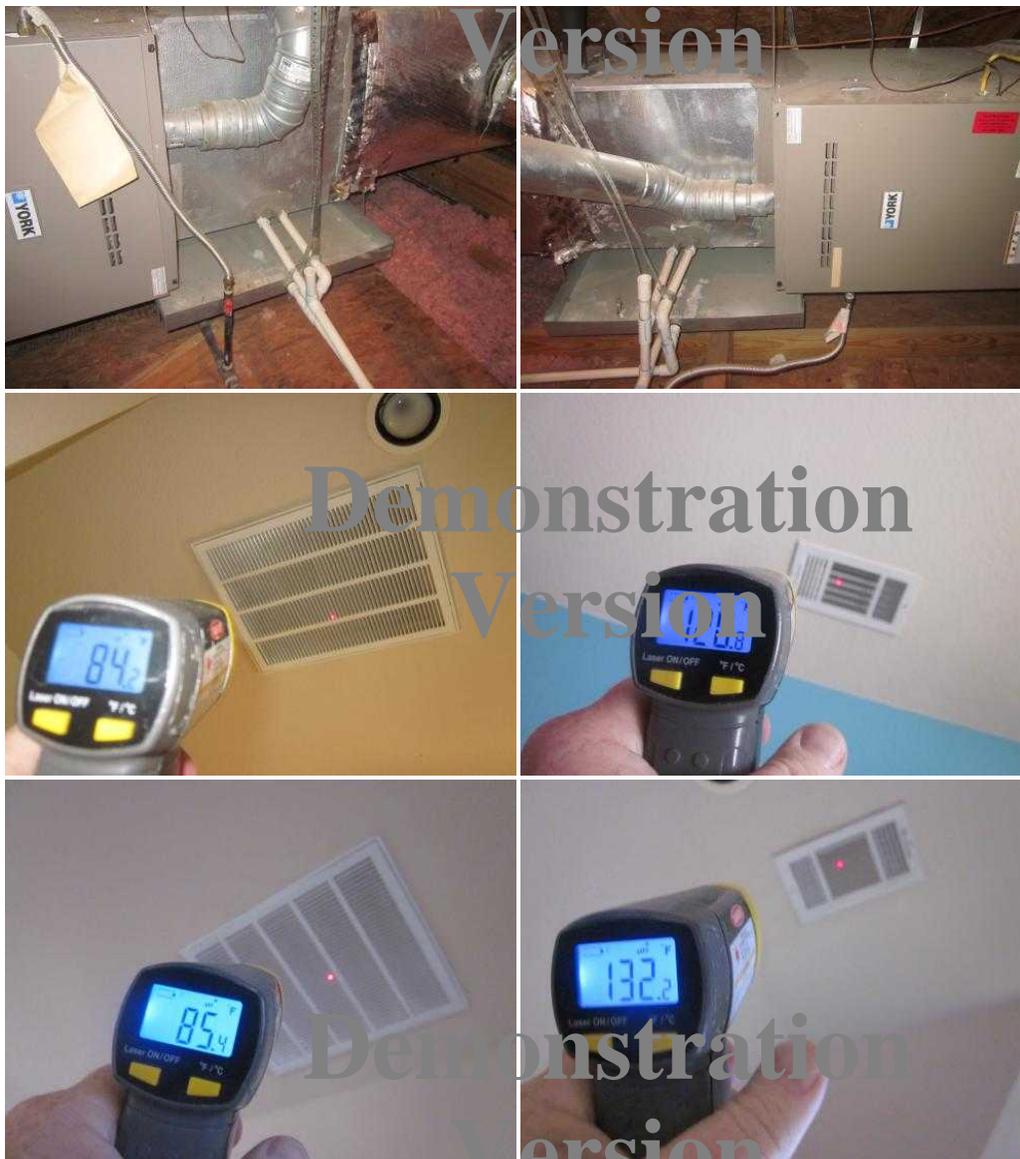
Comments: York Appears to be functioning as intended at the time of this inspection but due to the limitations of temperature restriction during the warmer winter it is difficult to get a representative reading on the air flow.

If additional concerns exist then a full evaluation should be completed by a qualified HVAC company.

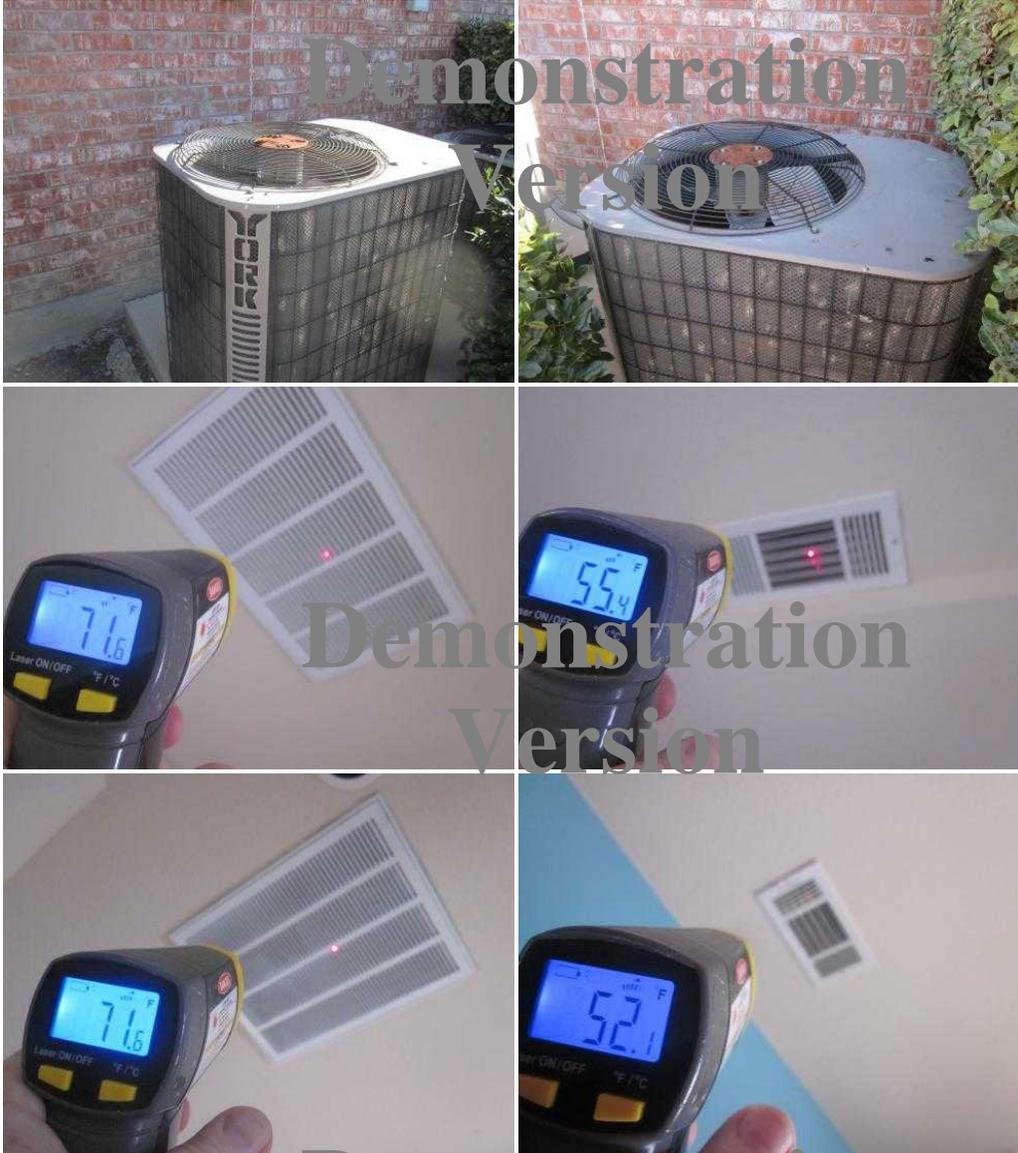
Comments: Both units appeared to be functioning at the time of the inspection and appeared to be within the acceptable temperature differential guidelines of 15 degrees between the return and supply. If additional concerns exist regarding the integrity of the system then it is recommended that a full evaluation should be completed by a qualified HVAC company.

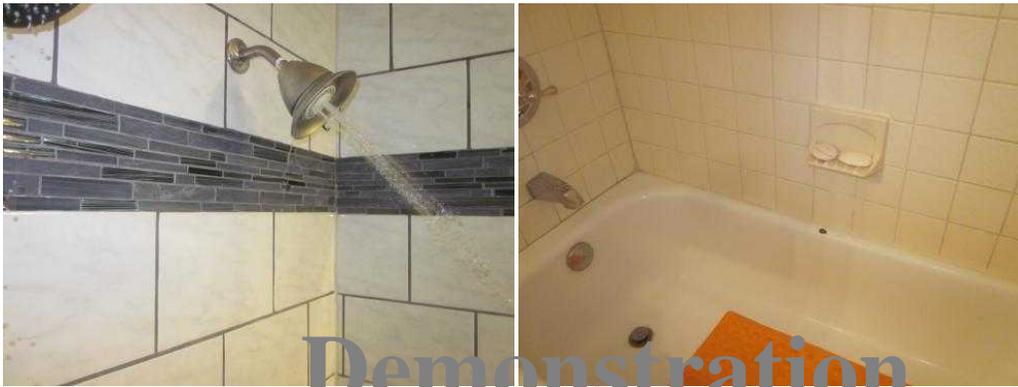
Comments: Copper Master bathroom leak noted around the shower head connection and should be repaired.

Chip is noted in the upstairs bathroom and should be repaired and caulk repairs are also recommended.

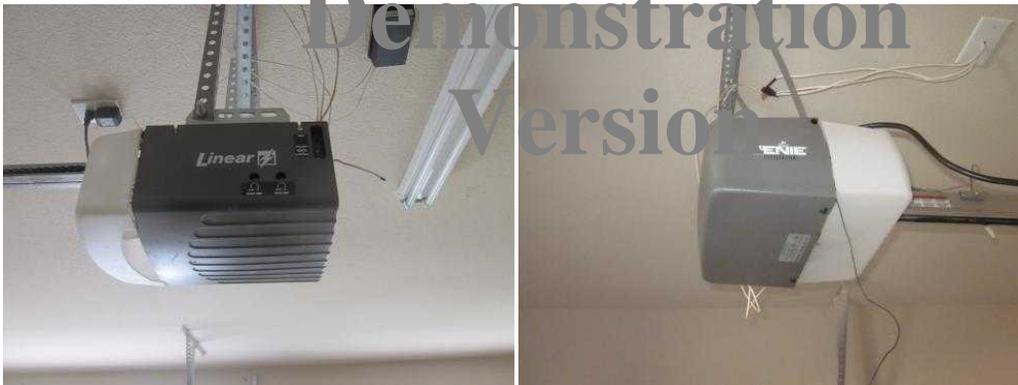
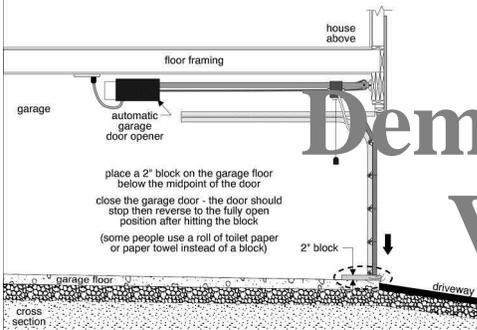
Testing automatic reverse

G. Garage Door Operators - Comments: Genie, Linear, The garage door opener did not automatically reverse under resistance to closing. There is a serious risk of injury, particularly to children, under this condition. Improvement may be as simple as adjusting the sensitivity control on the opener. This should be repaired immediately.

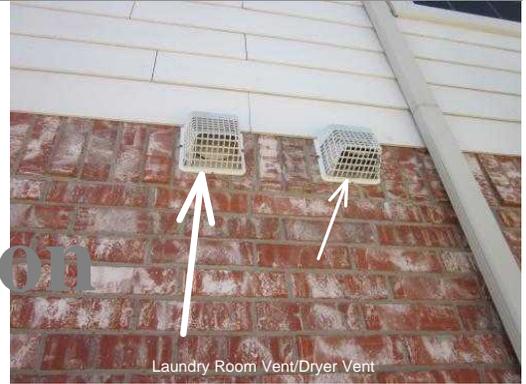
H. Dryer Exhaust Systems - Comments: Rigid metal, Small amount of blockage is noted in the dryer vent discharge and should be cleaned.

Appears that the discharge dryer line is within acceptable guidelines of 25 feet or less.

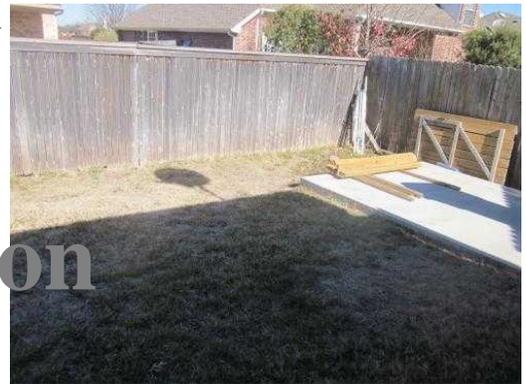
A. Landscape Irrigation (Sprinkler) Systems - Comments: Front and back yard, Recommend redirecting the spray away from the structure of the home and the fence

No coverage noted for the northwest corner of the yard. Further repairs are recommended.

10 zones present.

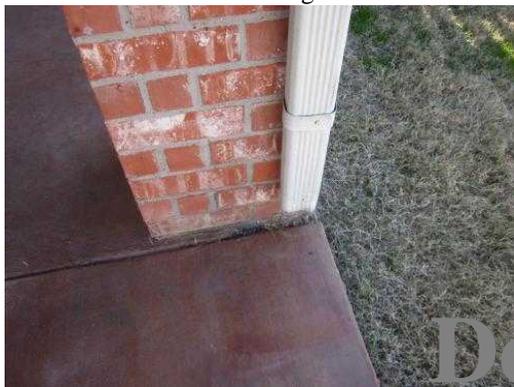
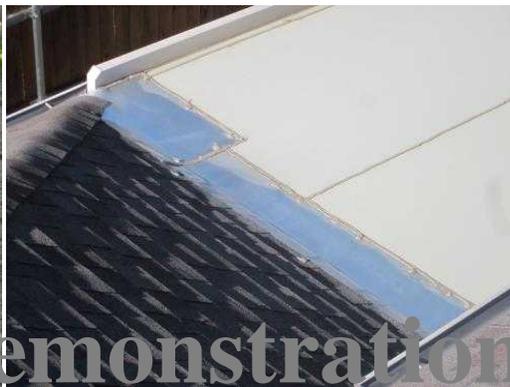
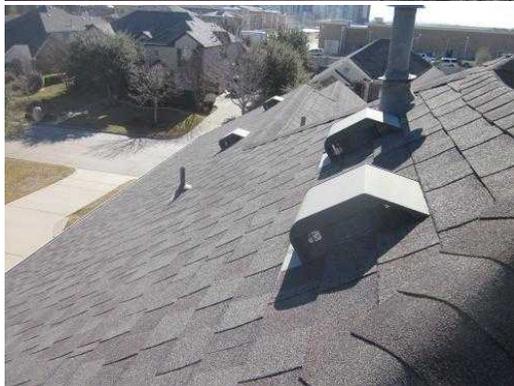
C. Roof Covering Materials Asphalt shingle, Recommend monitoring the flashing from the main roof line to the patio covering. Although functioning at the time of this inspection these particular areas can be vulnerable over time and may need repairs in the future.

Recommend repairing the downspouts around the perimeter of the home to allow for proper discharge.

Final picture is just to illustrate that the profile vents were installed and appeared to be functioning as intended at the time of this inspection.

Due to the nature of the architectural design it is recommended the area above the front entrance be monitored for any future leaks due to the type of water discharge on this design of home. Although no moisture is noted at the time of this inspection it is recommended that the area be monitored and repaired if and when repairs are needed. Types(s) of Roof Covering: Composition
Viewed From: Walking on Roof

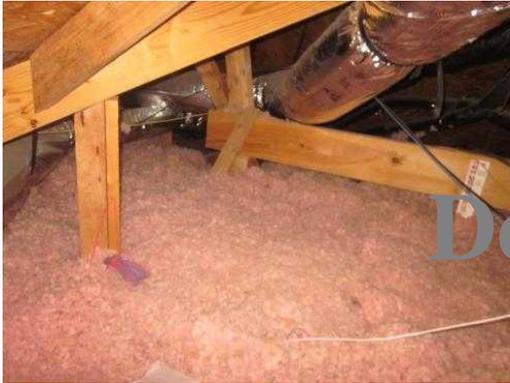
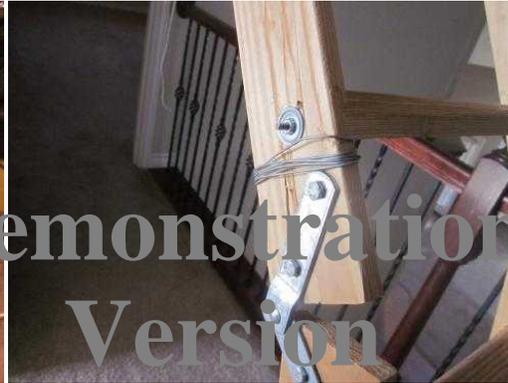
D. Roof Structures and Attics 2x6 Truss, Insulation levels are appropriate at the time of the inspection and no additional insulation is recommended at this time.

Recommend repairing the attic ladder to prevent injury or damage. Viewed From: Entering the attic Approximate Average Depth of Insulation: 8 - 12 inches

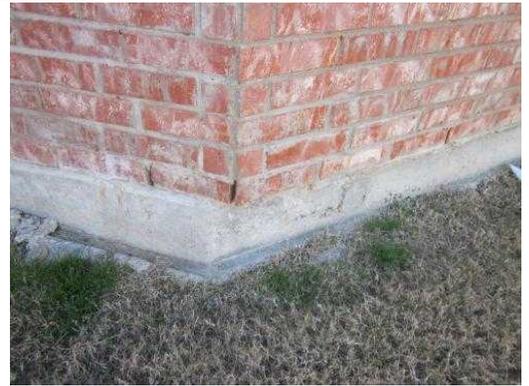
E. Walls (Interior and Exterior) Drywall/Brick, Nail pops are noted in various locations and should be repaired in the near future.

The interior of the home is need of cosmetic repairs, but overall structural condition appears to be functioning as intended at the time of this inspection.

It appears that the exterior brick line is over hanging from the original concrete layout. Does not appear to be affecting the performance of the foundation but recommend monitoring and repair as needed.

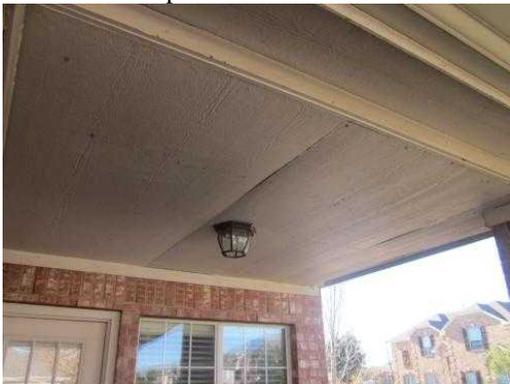
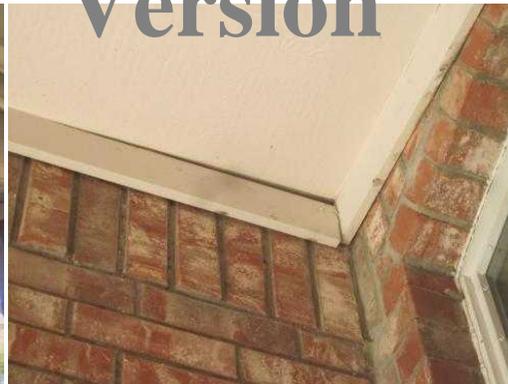
F. Ceilings and Floors Drywall and Carpet, The exterior patio door is showing signs of sagging which may be caused by water intrusion into the area or from improper installation. Further evaluation may be warranted to determine the actual cause.

Areas of separation area noted around various locations of the exterior trim and should be repaired.

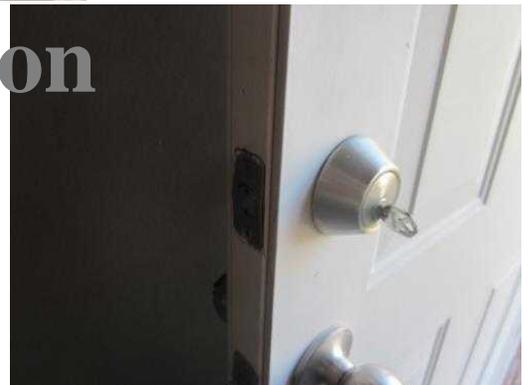
G. Doors (Interior and Exterior) Insulated steel doors, The dead bolt lock does not line up properly for the smaller garage door. Further adjustments are recommended to allow for ease of use.

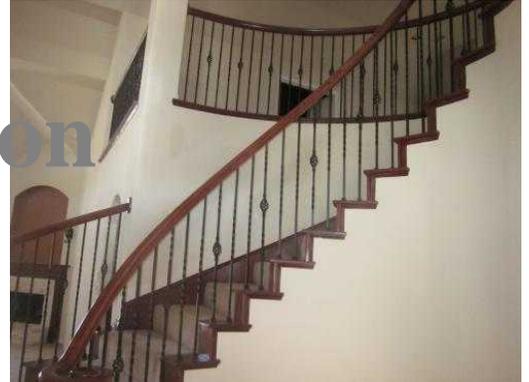
I. Stairways (Interior and Exterior) Wood stairs with wood handrails, The stairway banister and rail are loose and should be secured.

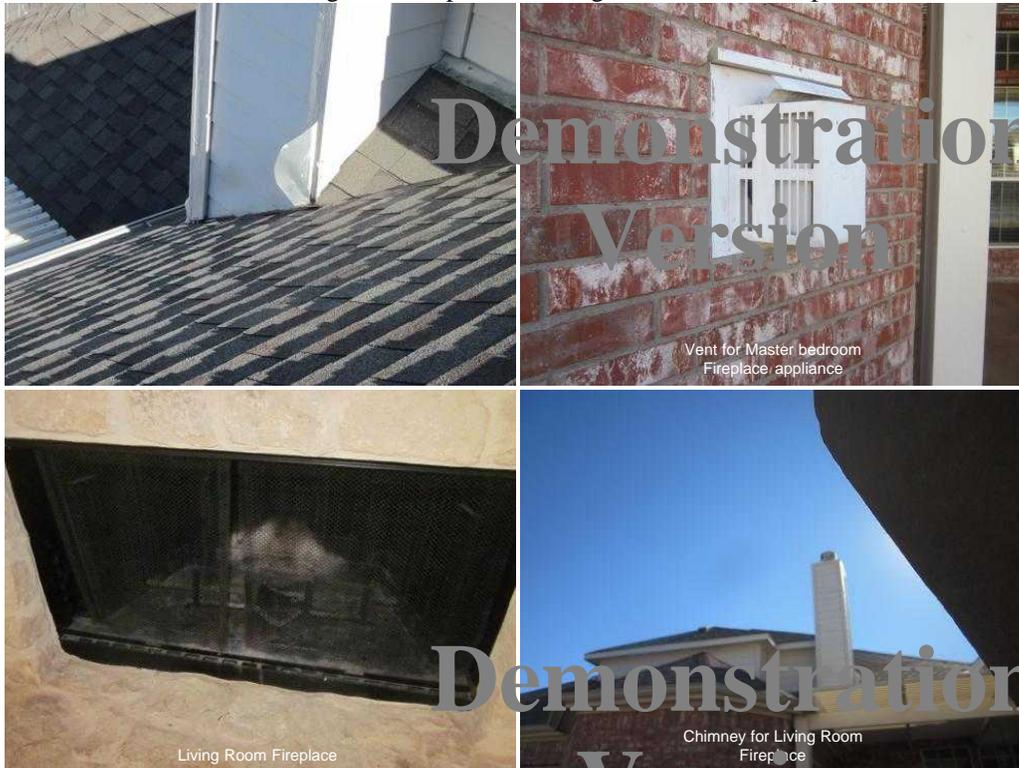
J. Fireplaces and Chimneys Prefab, Wood trim for the living room chimney is showing signs of rot and should be repaired in the near future.

Recommend cleaning out the living room fireplace.

Fresh air vent for the living room fireplace is damaged and should be replaced.

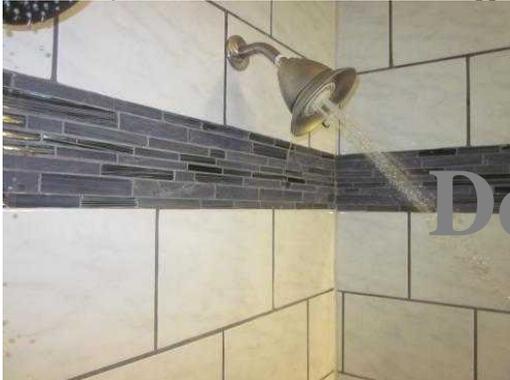
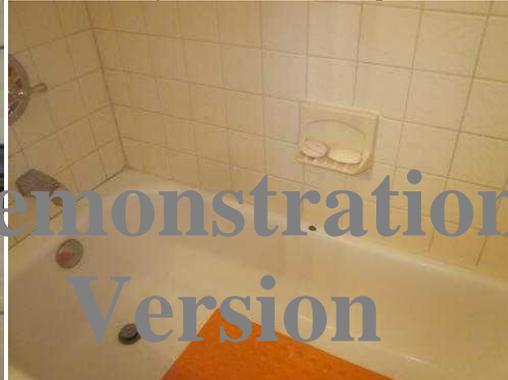
A. Plumbing Supply, Distribution Systems and Fixtures Copper, Master bathroom leak noted around the shower head connection and should be repaired.

Chip is noted in the upstairs bathroom and should be repaired and caulk repairs are also recommended. Location of water meter: Front yard Location of main water supply valve: Front yard Static water pressure reading: 60-70 lbs

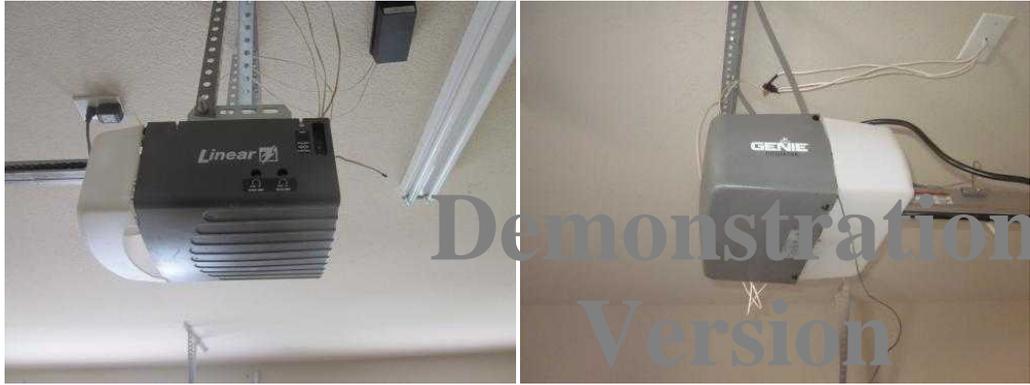
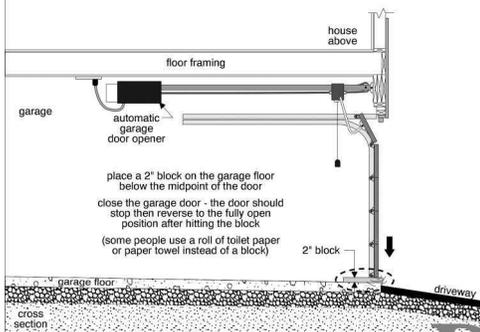
Testing automatic reverse

G. Garage Door Operators Genie, Linear The garage door opener did not automatically reverse under resistance to closing. There is a serious risk of injury, particularly to children, if this condition is not corrected. Improvement may be as simple as adjusting the sensitivity control on the opener. This should be repaired immediately.

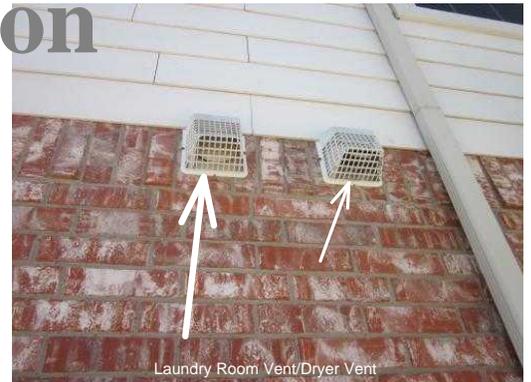
H. Dryer Exhaust Systems Rigid metal, small in diameter, locking is noted in the dryer vent discharge and should be cleaned.

Appears that the discharge dryer line is within acceptable guidelines of 25 feet or less.

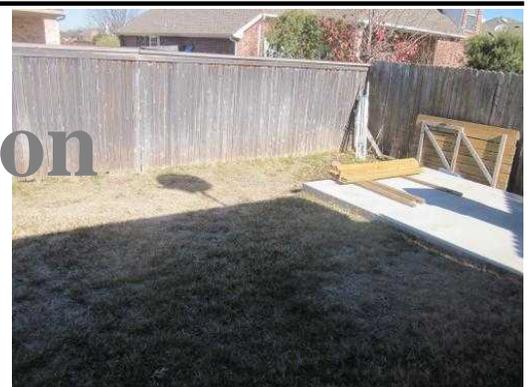
A. Landscape Irrigation (Sprinkler) Systems Front and back yard, Recommend redirecting the spray away from the structure of the home and the fence

No coverage noted for the northwest corner of the yard. Further repairs are recommended.

10 zones present.
