Demonstration Home Inspection Report

555 Anywhere Street
Typical USA
Demonstration
Version

PROPERTY INSPECTION REPORT

Concerning: 555 Anywhere street Typical, us

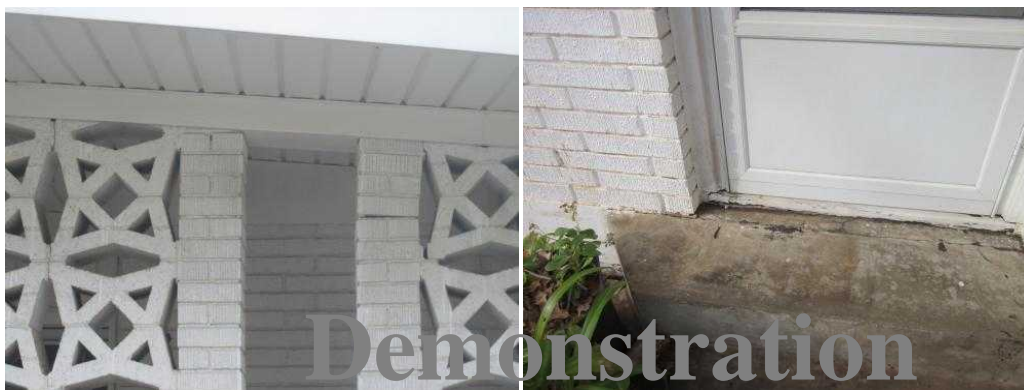
Comments: Slab The foundation appears to have had movement that may be beyond normal, due to the evidence of previous foundation work. You are strongly encouraged to consult the current homeowner on previous foundation work done and warranty information. The client should have an engineer give an evaluation if any concerns exist about the possibility of future movement.

The foundation has had some settlement; the amount of settlement observed is not uncommon to see in this region and for the age of the home. This is a cursory and visual observation of the conditions and circumstances present at the time of this inspection.

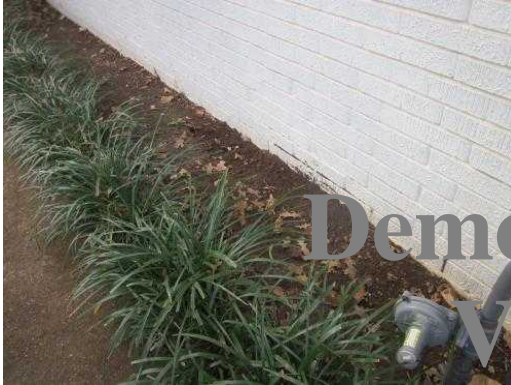
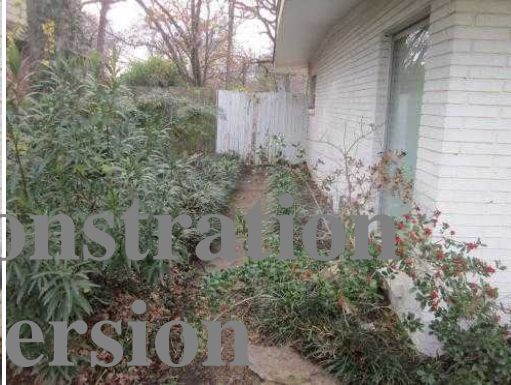
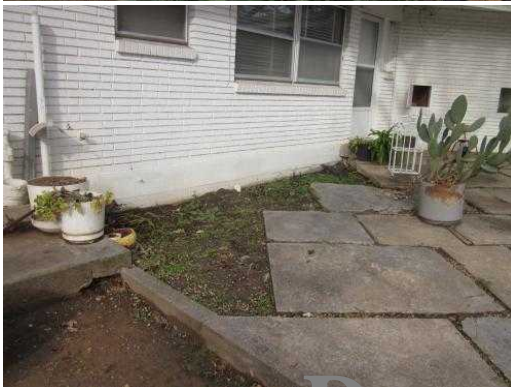
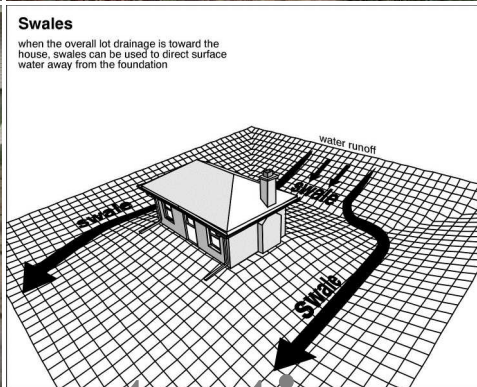
B. Grading and Drainage (continued)

Evidence of historical moisture intrusion is noted on the interior of the home and should be closely monitored and repaired as needed.

Grading has negative slope and water is pooling against the foundation., Improper soil slope towards foundation, recommend the addition of fill dirt to improve grade;

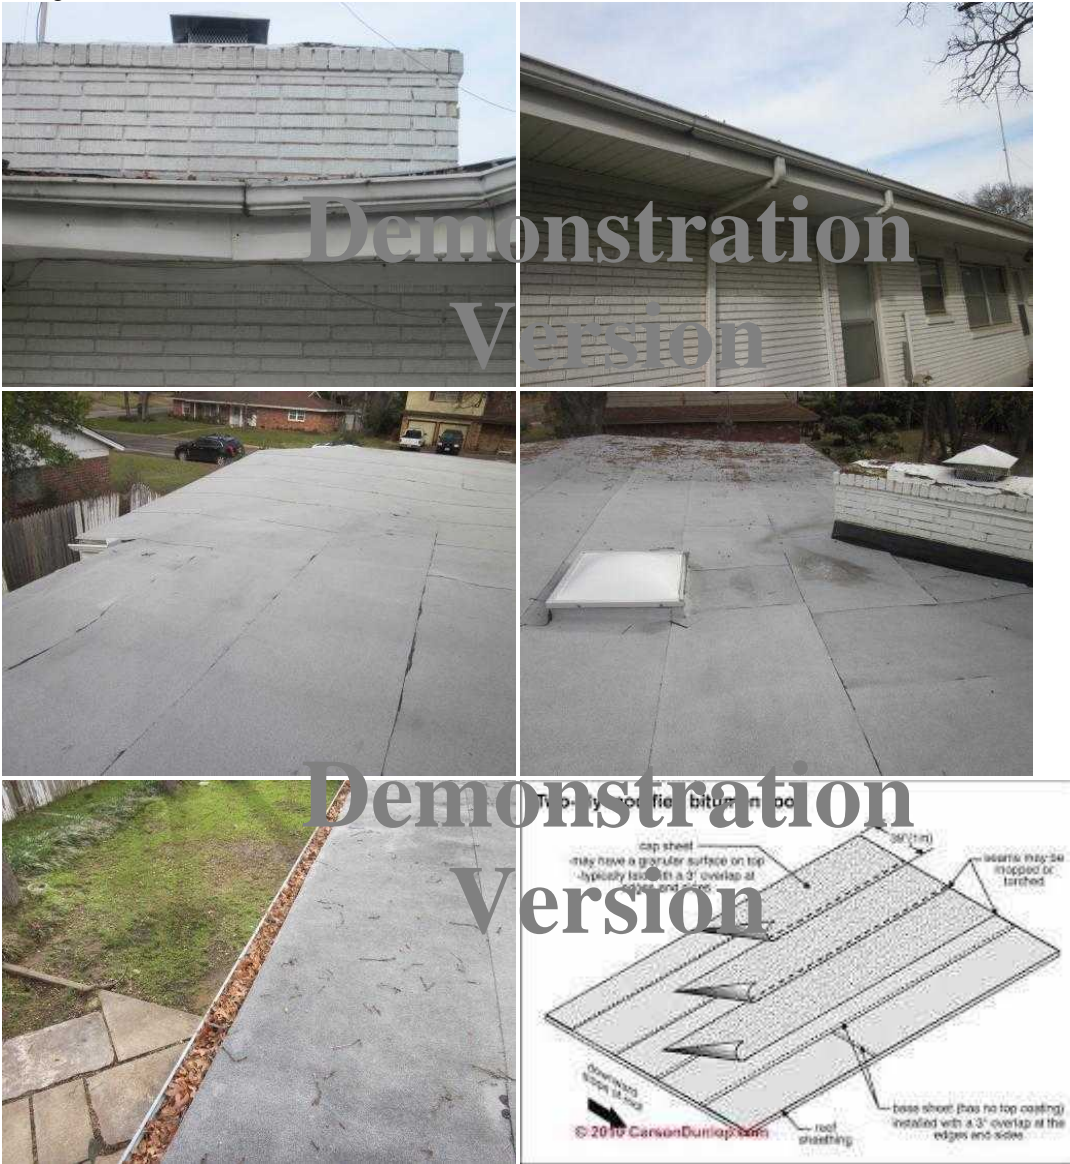
C. Roof Covering Materials (continued)

Comments: Asphalt shingle Variations in the roofing material and sub structure are noted in various locations which is fairly commone with the type of material and structural design

Evidence of water penetrations are noted around the chimney area and should be further investigated and repaired by a qualified roofing company.

Standing water and repairs are noted in various location and should be evaluated to determine the extent of repairs that possibly may be needed and any water intrusion that may have caused damage to the sub structure.

The gutters should be cleaned and repaired to allow proper discharge of water around the home.

Recommend monitoring the skylights and repair if and when repairs are needed.

Evidence of water damage is noted on the north west eve of the home. Unable to determine the cause but further evaluation and repairs should be completed

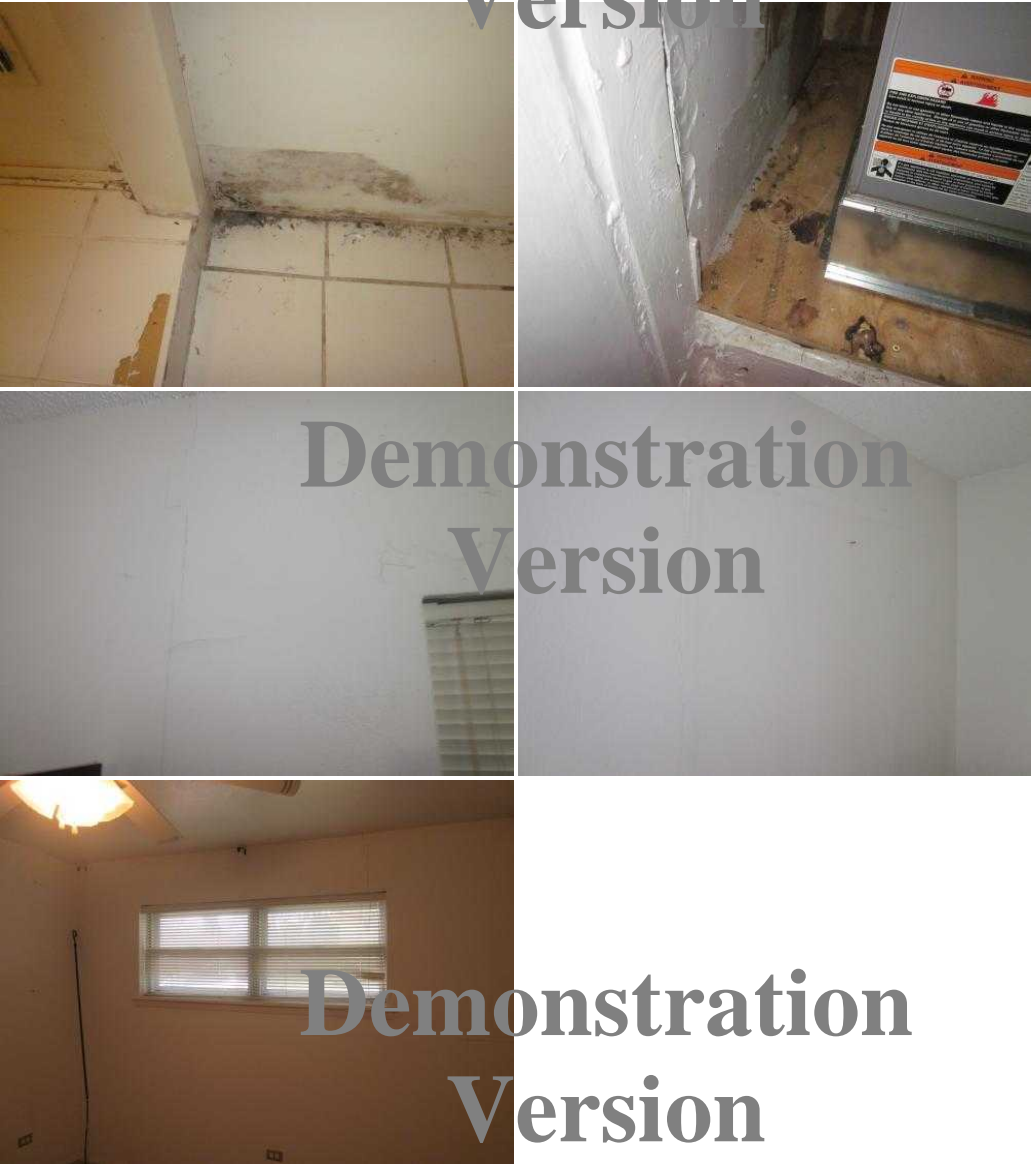
☐☐☐☒ **E. Walls (Interior and Exterior)** - Comments: Drywall/Brick, Typical movement and standard wear and tear is noted on the exterior and interior of the home. Any repairs that are completed would be considered cosmetic in nature.

Due to the foundation movement over that years there is evidence of structural interior wall cracks that will need to be repaired after any foundation repairs have been completed.

Evidence of water damage is noted on the opposing wall of the A/C unit. No moisture is noted at the time of this inspection but historical damage is noted and should be repaired in the near future.

Evidence that the water penetration was from a historical primary line blockage from the a/c unit. It appears that this has been resolved but historical water damage repairs will be needed.

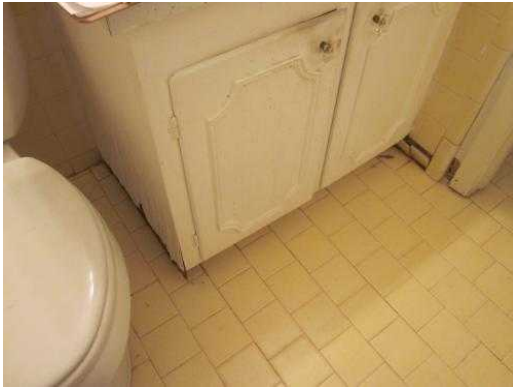
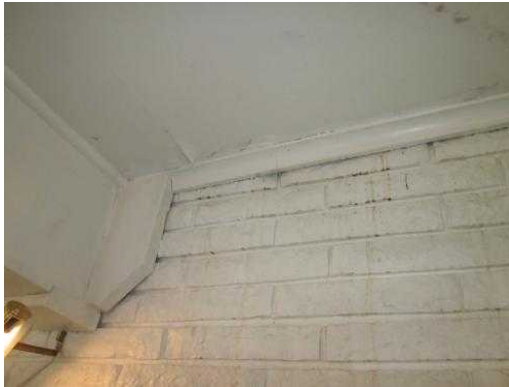
- ☐☐☐☒ **F. Ceilings and Floors** - Comments: Drywall and Carpet, Evidence of water intrusion is noted on the south bathroom. Recommend that further evaluation be completed to determine the extent of damage and exactly where water intrusion is occurring.

The water damage in the south bathroom appears to have been caused by a historical A/C issue and may require some repairs in the near future.

Ceiling stain in the fireplace ceiling area is coming from a roof leak and the inspector is unable to determine the exact location, but further evaluation and repair are recommended.

Cosmetic drywall improvements are needed in the entire interior of the home after any foundation repairs are completed. Otherwise all interior updates will be considered cosmetic in nature.

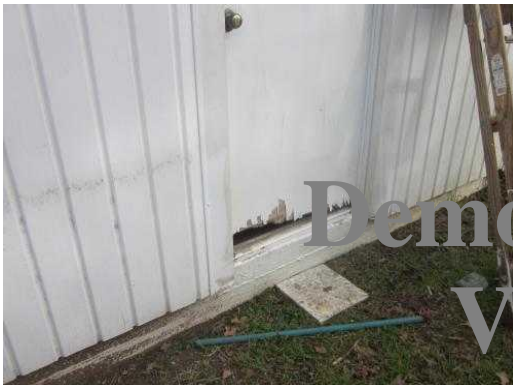
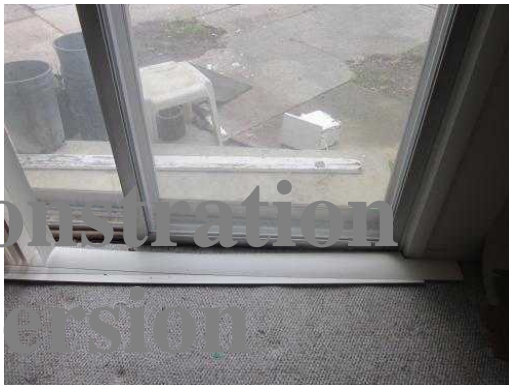
- ☐☐☐☒ **G. Doors (Interior and Exterior)** - Comments: Hollow wood, Solid wood, Insulated wood sliding doors, The sliding glass door does not appear to have a shutter or locking noted on the glass. This may indicated possible issues to anyone were to have an accident or other possible damage to the door.

Kitchen pocket door was not functioning at the time of this inspection and should be repaired.

Door rotting is noted on the storage area of the garage and should be repaired or replaced in the near future.

Garage door adjustments will be needed to allow for ease of use if the garage door operator is not replaced.

Front entrance storm door is in near of handle repair.

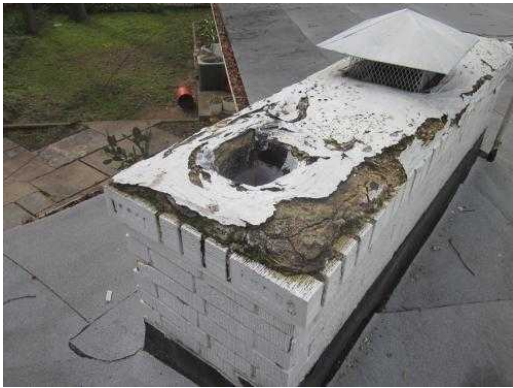
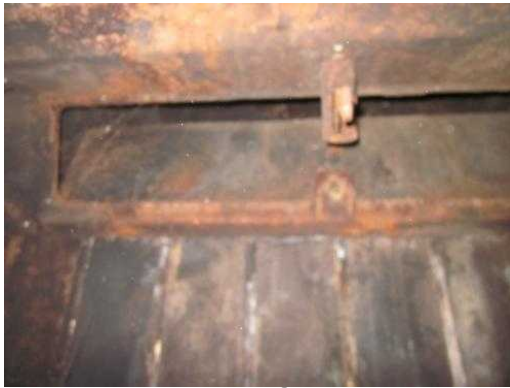
☐☐☐☒ **J. Fireplaces and Chimneys** - Comments: Block, Brick, Damper block is recommended to allow any excess gases to escape from the interior of the gas log area.

The rain cap/vermin screen is missing and should be replaced.

The actual chimney cap is showing signs of deterioration and should be repaired.

Evidence of water intrusion into the chimney area should be rectified.

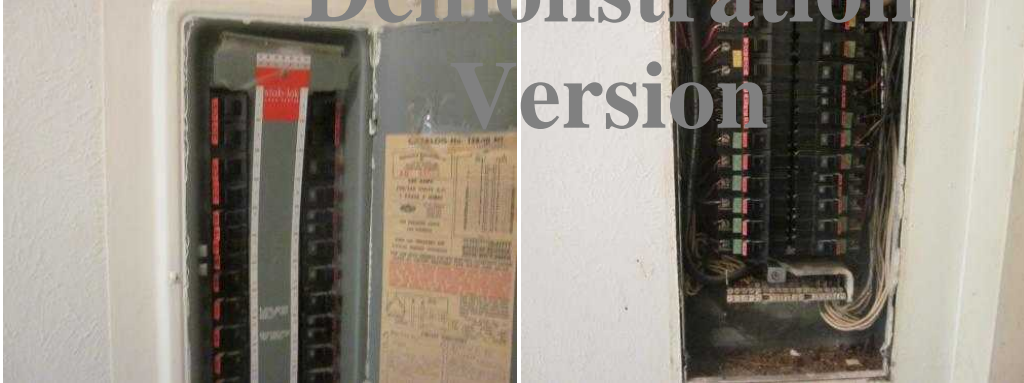
- ☐☐☐☒ **A. Service Entrance and Panels** - Comments: Copper, Due to the nature of the federal stab-loc service box noted in this location, it common for the inspectors to write them up as deficient because they are not longer being used in building process. There is documented evidence of this type of panel having loose breakers noted and could cause possible electrical shorts. However, this panel did not shows any electrical shorting.

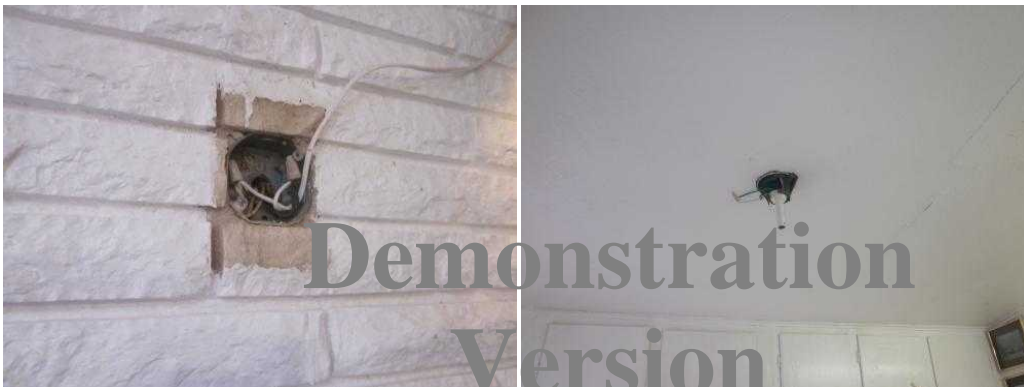
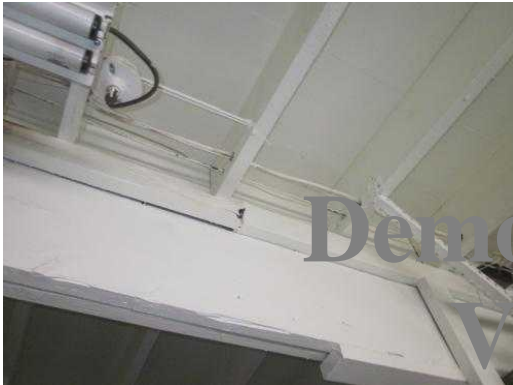
B. Branch Circuits, Connected Devices, and Fixtures (continued)

Comments: Copper Recommend installing GFCI's in the kitchen and bathrooms were needed or possible.

Open electrical box is noted in the kitchen lighting area and should be repaired.

Loose outlets are noted in various locations and should be repaired.

Ungrounded outlets are noted in various bedrooms which is not uncommon for the era in which the home was built.

The ceiling fan/light is missing in the kitchen and should be repaired.

All exposed electrical wiring located in the garage area should be enclosed in conduit.

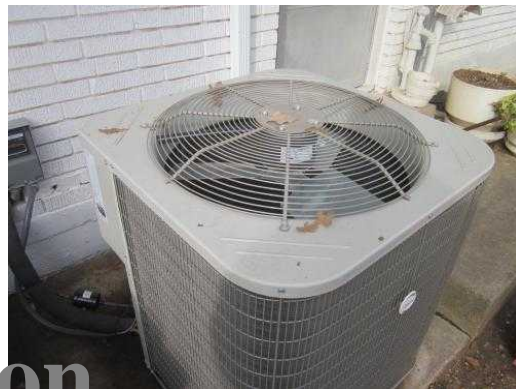
Comments: Payne Unit appeared to be operating normally but a full system blower check was not completed due to the limitations of temperature restrictions at the time of year.

Evidence of previous primary line blockage is noted and should be monitored and repaired as needed.

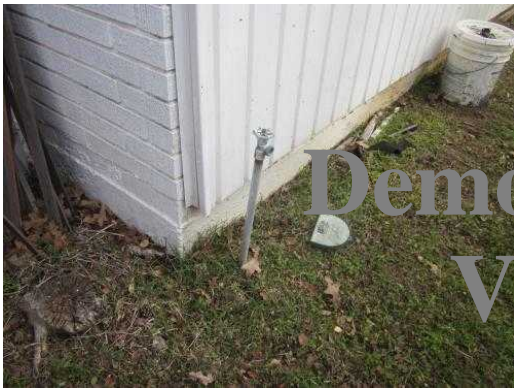
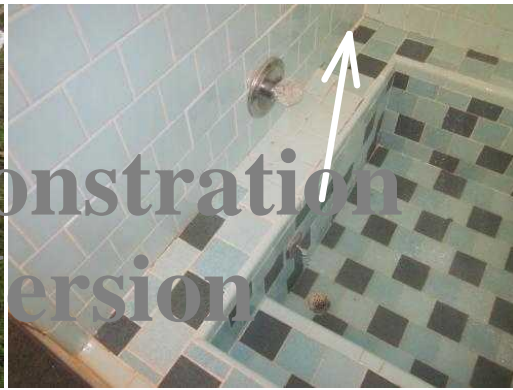
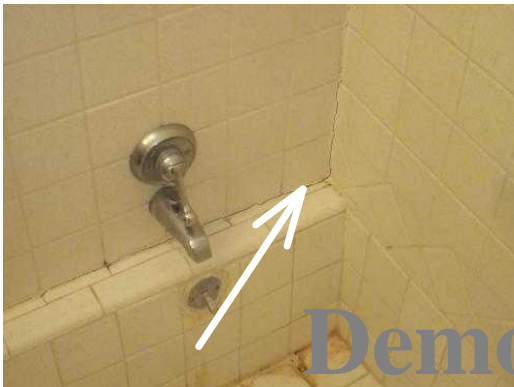
Comments: Copper The outside garage faucet is not functioning and should be repaired. The inspector is unable to determine the cause.

Grout and caulking repairs are recommended in the master and the hallway bathrooms.

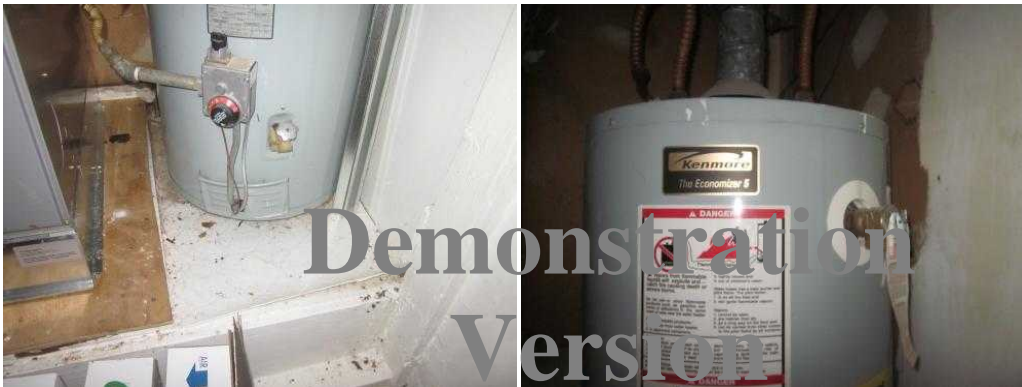
Comments: Kenmore Life expectancy of a water heater, on average is about 7 to 12 years. Recommend monitoring and repair if and when repairs are needed.

The water heater does not have a pan installed beneath the water heater and should be corrected. The note is however, that when this home was built the water heaters did not require a pan beneath the unit.

The temperature pressure relief line is not connected to a discharge line to the exterior of the home and should be repaired.

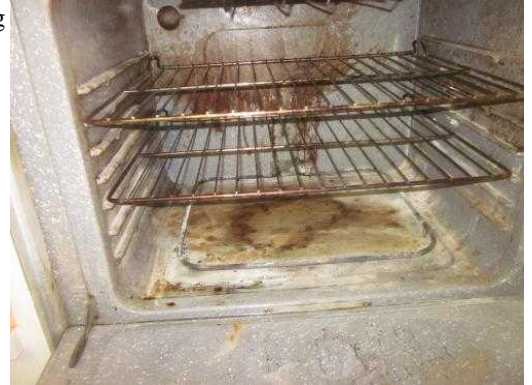
☐☐☒ **D. Ranges, Cooktops, and Ovens** - Comments: Whirlpool - Functioning at the time of this inspection but should be repaired.

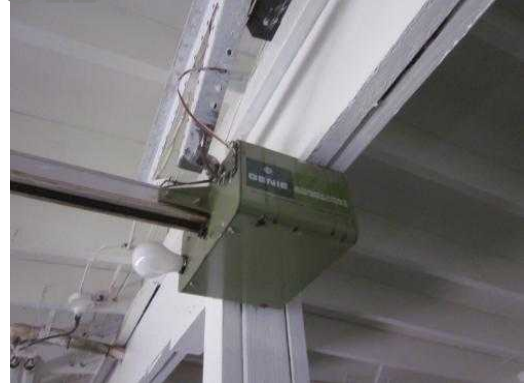
☐☐☒ **G. Garage Door Operators** - Comments: Overhead Door, Garage door operator was not functioning at the time of this inspection and should be repaired.

The garage door opener did not automatically reverse under resistance to closing. There is a serious risk of injury, particularly to children, under this condition. Improvement may be as simple as adjusting the sensitivity control on the opener. This should be repaired immediately.
