Demonstration Version *Home Inspection Report*

555 Anywhere USA

PROPERTY INSPECTION REPORT

Prepared For: Bob Everybody
Concerning: 555 Anywhere Street Typical, US
Inspection Date: 1/28/2016
By: Inspector Name: Demonstration Inspector License Number: 6199 Date:
Signature:
Phone: E-Mail:

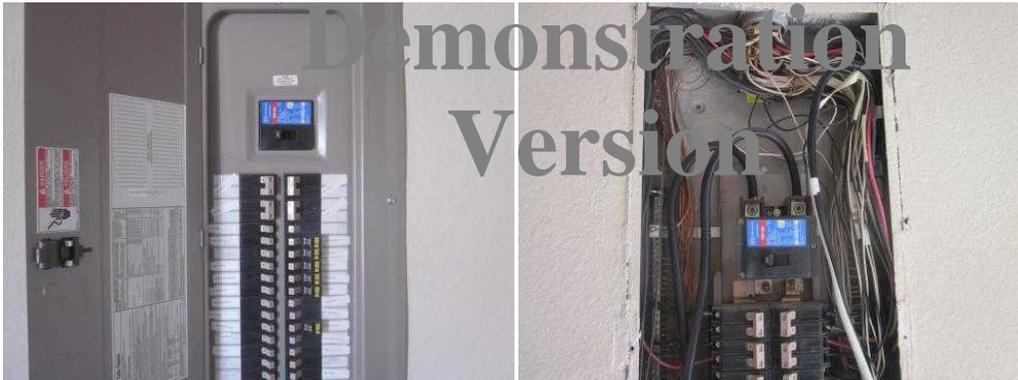
A. Service Entrance and Panels - Comments: Copper, Appears to be functioning as intended at the time of this inspection.
