Demonstration Home Inspection Report

555 Anywhere Street
Typical USA
Demonstration
Version

PROPERTY INSPECTION REPORT

Concerning: 555 Anywhere street Typical, us

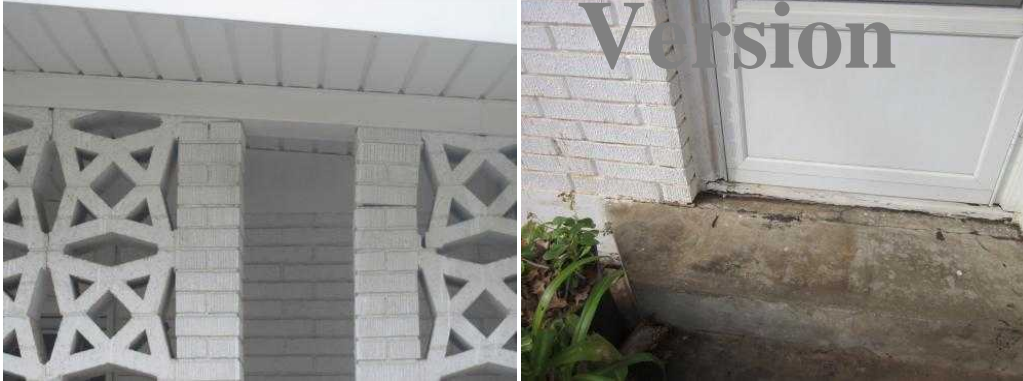
The foundation has had some settlement; the amount of settlement observed is not uncommon to see in this region and for the age of the home. This is a cursory and visual observation of the condition and circumstances present at the time of this inspection.

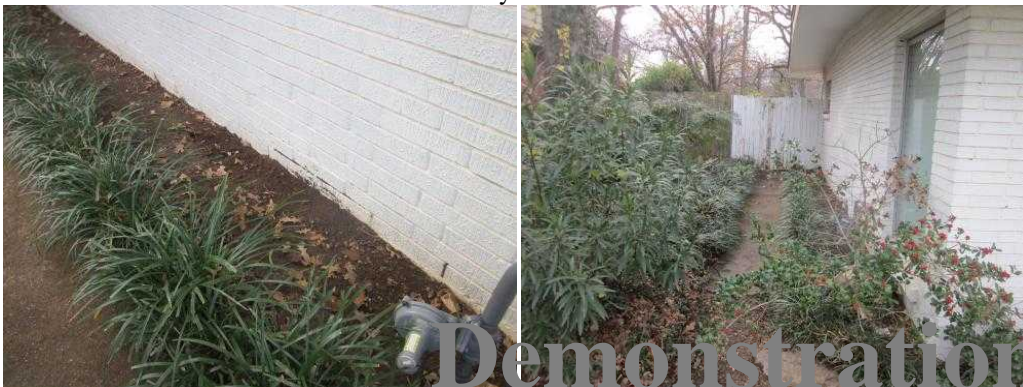
- B. Grading and Drainage Negative slope, Due to the nature of the home being built lower than the neighbor to the south it will be difficult to control storm water in all circumstances.

Evidence of historical moisture intrusion is noted on the interior of the home and should be closely monitored and repaired as needed.

Grading has negative slope and water is pooling against the foundation. Improper soil slope towards foundation, recommend the addition of fill dirt to improve grade,

The general topography of the area is such that it will be difficult to control storm water entirely. During heavy rains the accumulation of storm water on the lot may be unavoidable.

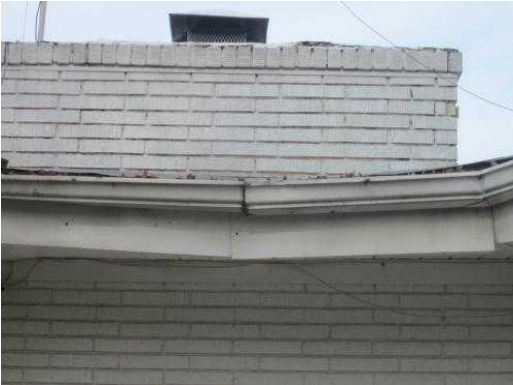
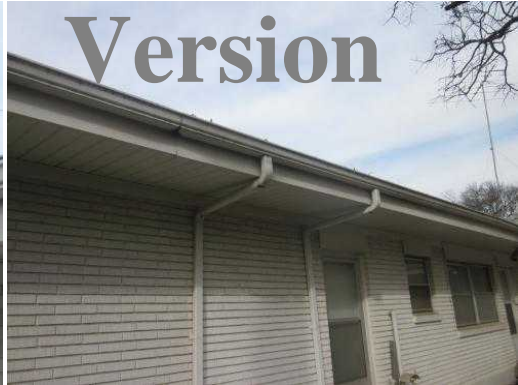
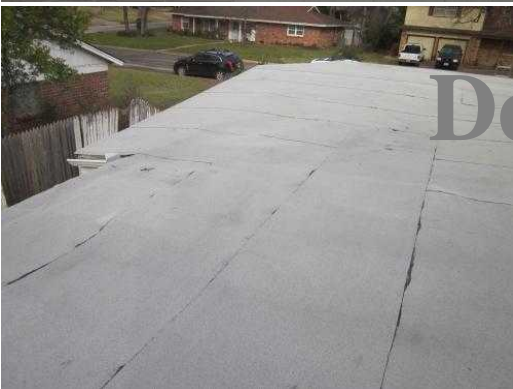
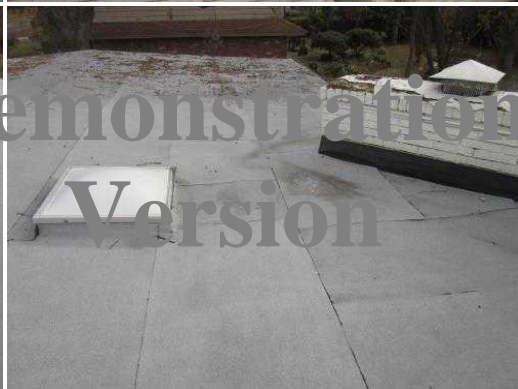
C. Roof Covering Materials Asphalt shingle, Variations in the roofing material and sub structure are noted in various locations which is fairly commone with the type of material and structural design

Evidence of water penetrations are noted around the chimney area and should be further investigated and repaired by a qualified roofing company.

Evidence of water damage is noted on the north west side of the home. Unable to determine the cause but further evaluation and repairs should be completed. Types(s) of Roof Covering: Modified Bitumen Viewed From: Walking on Roof

Recommend monitoring the skylights and repair if and when repairs are needed.

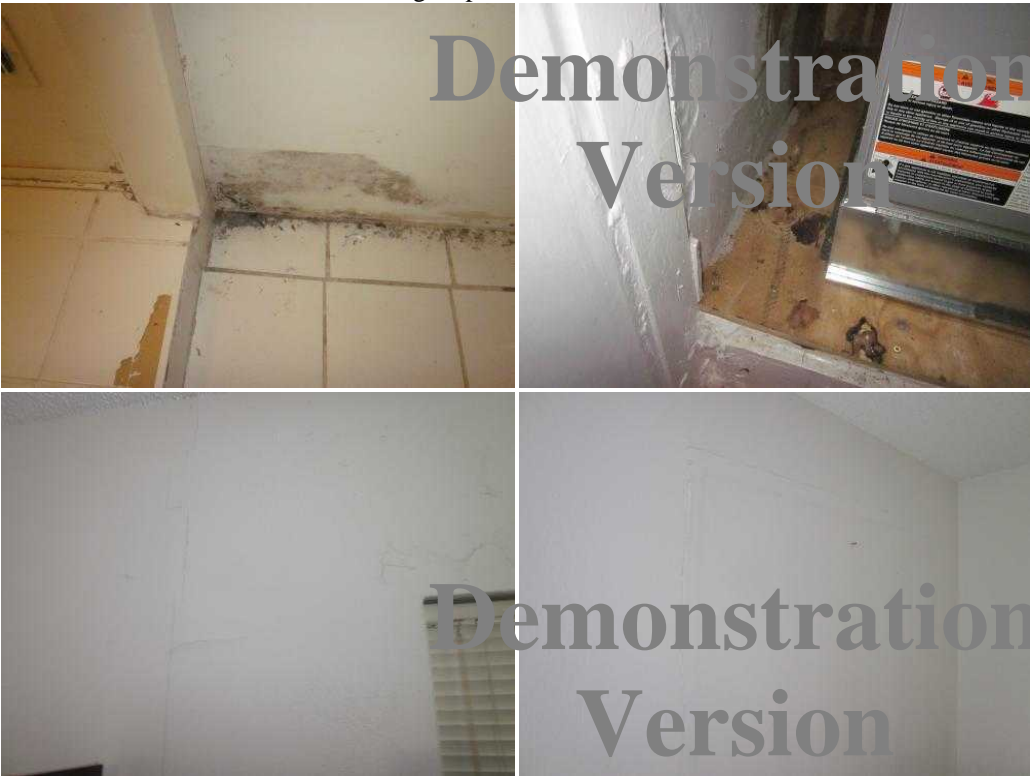
E. Walls (Interior and Exterior) Drywall/Brick, Typical movement and standard wear and tear is noted on the exterior and interior of the home. Any repairs that are completed would be considered cosmetic in nature.

Due to the foundation movement over that years there is evidence of structural interior wall cracks that will need to be repaired after any foundation repairs have been completed.

Evidence of water damage is noted on the opposing wall of the A/C unit. No moisture is noted at the time of this inspection but historical damage is noted and should be repaired in the near future.

Evidence that the water penetration was from a historical primary line blockage from the a/c unit. It appears that this has been resolved but historical water damage repairs will be needed.

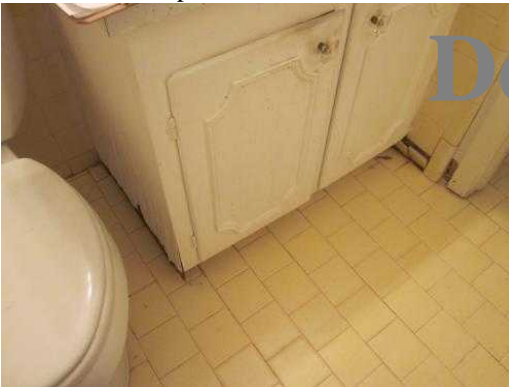
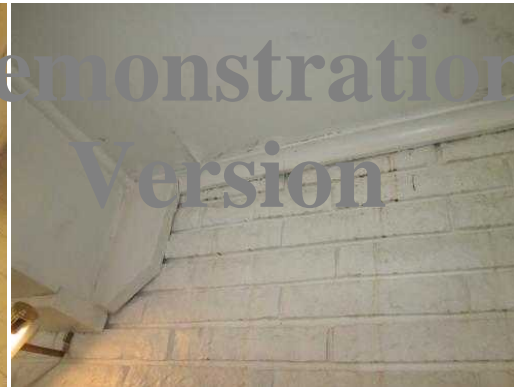
F. Ceilings and Floors Drywall and Carpet, Evidence of water intrusion is noted on the south bathroom. Recommend that further evaluation be completed to determine the extent of damage and exactly where water intrusion is occurring.

Ceiling stain in the fireplace ceiling area is coming from a roof leak and the inspector is unable to determine the exact location, but further evaluation and repairs are recommended.

Cosmetic drywall improvements are needed in the entire interior of the home after any foundation repairs are completed. Otherwise all interior updates will be considered cosmetic in nature.

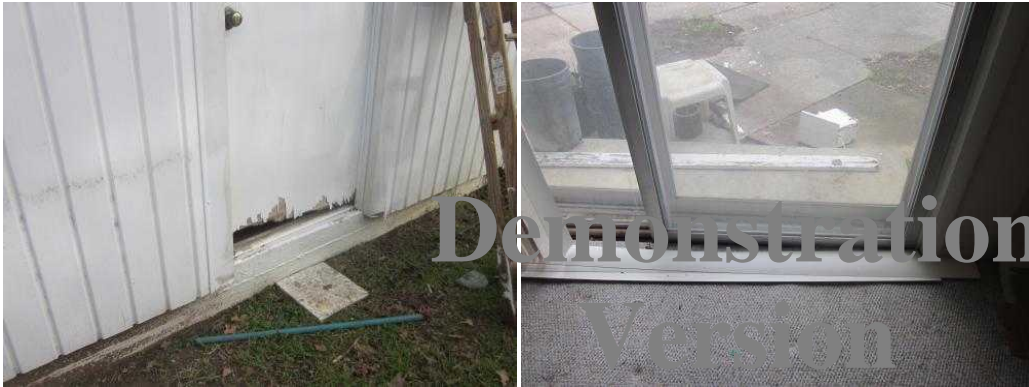
G. Doors (Interior and Exterior) (continued)

G. Doors (Interior and Exterior) Hollow wood, Solid wood, Insulated wood sliding doors, The sliding glass door does not appear to have a shatter proof labeling noted on the glass. This may indicate possible issues to anyone who were to have an accident or other possible damage to the door.

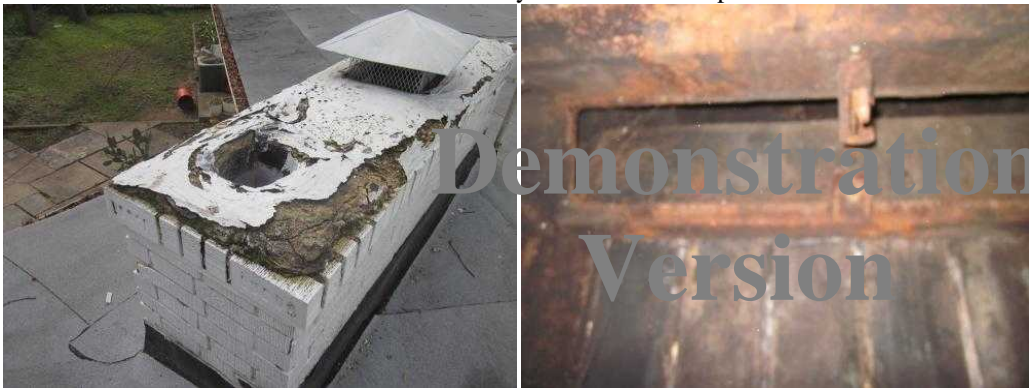
J. Fireplaces and Chimneys Block, Brick, Damper block is recommended to allow any excess gases to escape from the interior of the gas log area.

The rain cap/vermin screen is missing and should be replaced.

The actual chimney cap is showing signs of deterioration and should be repaired.

Evidence of water intrusion into the chimney area should be replaced.

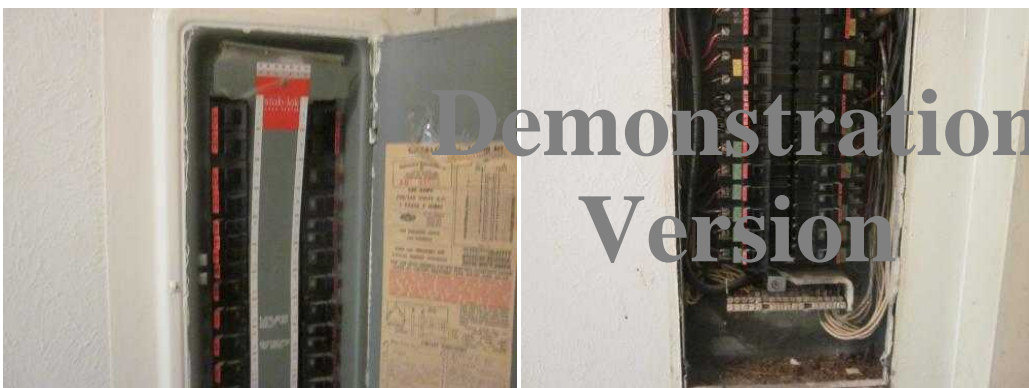
A. Service Entrance and Panels Copper, Due to the nature of the federal stab-loc service box noted in this location, it common for the inspectors to write them up as deficient because they are not longer being used in building process. There is documented evidence of this type of panel having loose breakers noted and could cause possible electrical shorts. However, this panel did not shows any electrical shorting.

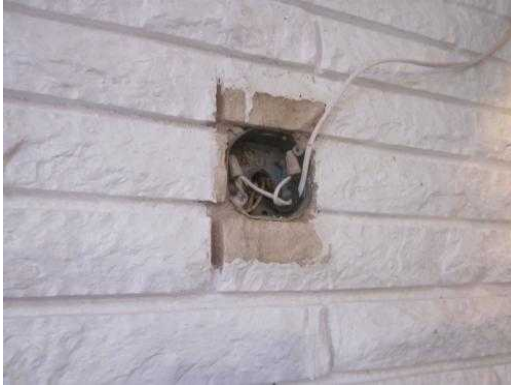
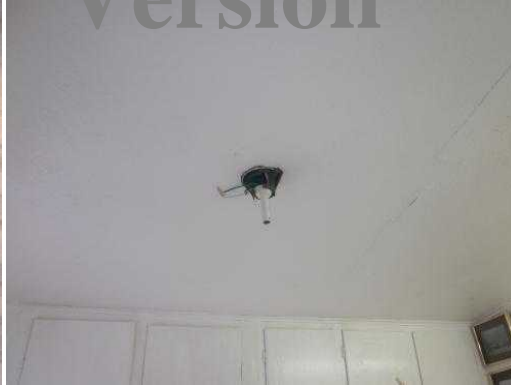
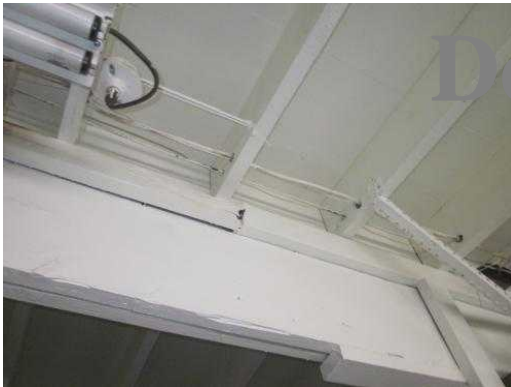
B. Branch Circuits, Connected Devices, and Fixtures Copper, Recommend installing GFCI's in the kitchen and bathrooms were needed or possible.

The ceiling fan/light is missing in the kitchen and should be repaired.

All exposed electrical wiring located in the garage area should be enclosed in conduit. Type of Wiring: Copper

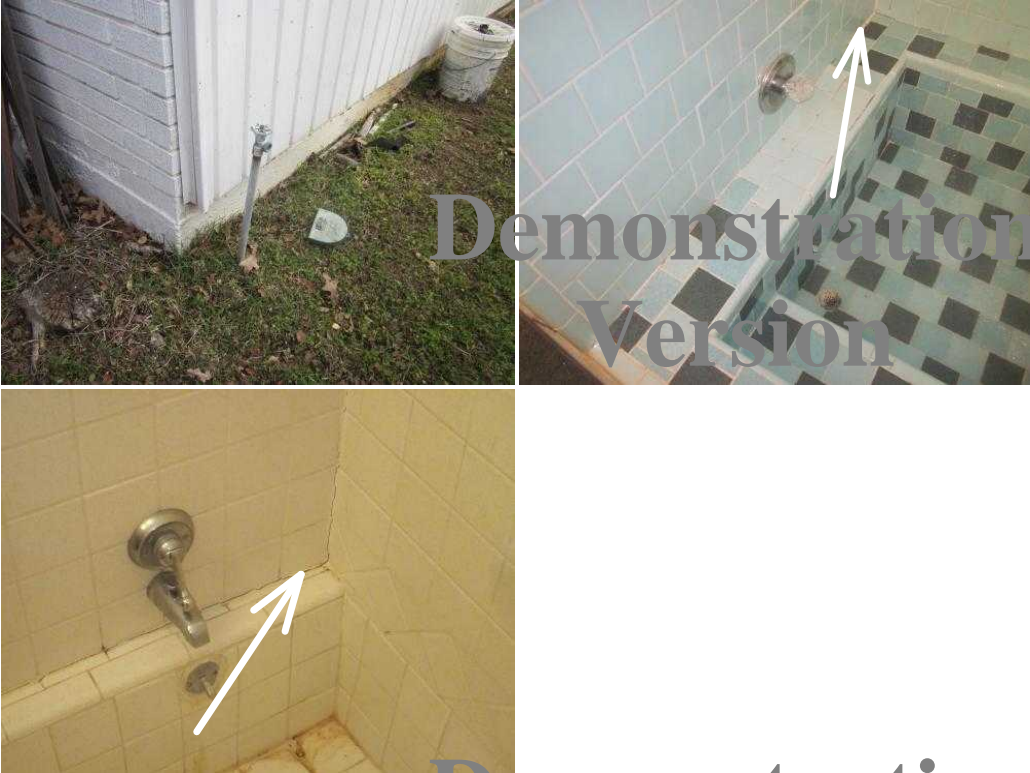
A. Plumbing Supply, Distribution Systems and Fixtures (continued)

A. Plumbing Supply, Distribution Systems and Fixtures Copper, The outside garage faucet is not functioning and should be repaired. The inspector is unable to determine the cause.

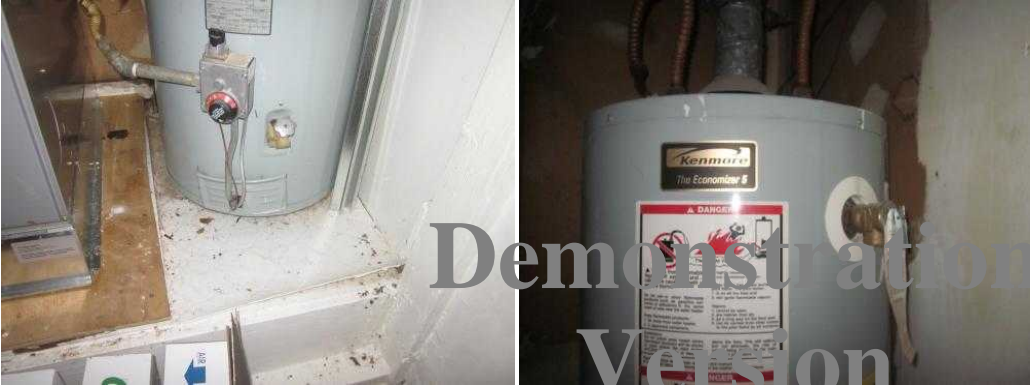
C. Water Heating Equipment Kenmore, life expectancy of a water heater, on average is about 10 to 12 years. Recommend monitoring and repair if and when repairs are needed.

The water heater does not have a pan installed beneath the water heater and should be corrected. The note is however, that when this home was built the water heaters did not require a pan beneath the unit.

The temperature pressure relief line is not connected to a discharge line to the exterior of the home and should be repaired.
Energy Source: Natural gas Capacity: 40 gallon installed in 1998

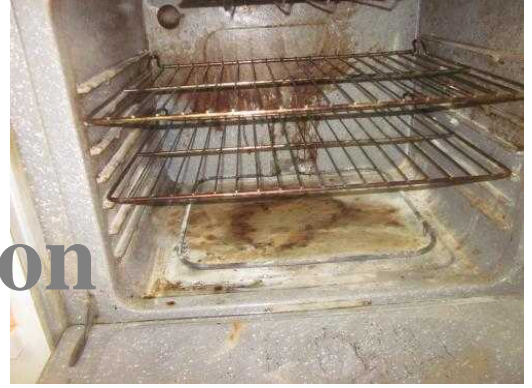
A. Dishwashers Maytag, Unit was not functioning at the time of this inspection and was leaking around the discharge tube.

D. Ranges, Cooktops, and Ovens Whirlpool, Functioning at the time of this inspection but should be repaired.

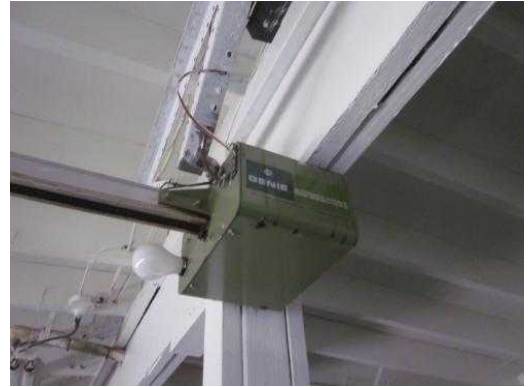
G. Garage Door Operators Overhead Door, Garage door operator was not functioning at the time of this inspection and should be repaired.

The garage door opener did not automatically reverse under resistance to closing. There is a serious risk of injury, particularly to children, under this condition. Improvement may be as simple as adjusting the sensitivity control on the opener. This should be repaired immediately.
